## **CALIBRATION SUMMARY**

### **GE RVI VIDEO BORESCOPIES & VERIFICATION BLOCK PRODUCTS**

#### **GE VIDEO BORESCOPIES WITH MEASUREMENT FEATURE**

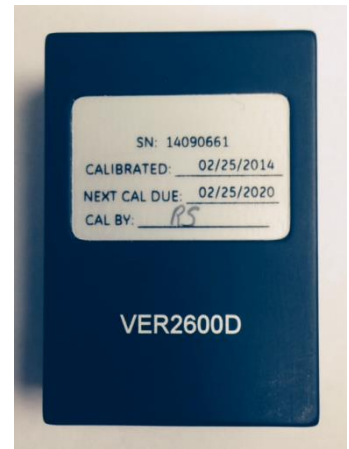
Measurement  
Verification Block  
(MVB)

A MVB is included with every VideoProbe which is sold including measurement optical tips. This device is a calibrated component with a 6-year Calibration Schedule from its original date of manufacture. It is an NIST traceable calibrated test block containing a test target used to verify measurement system accuracy. When the calibration period has expired, a GE RVI customer may replace the MVB with a new block, or send their block with the expired calibration date in to the Skaneateles, NY, USA authorized GE RVI repair center for re-calibration.

The MVB is shipped in the Optical Tip Case of the GE RVI VideoProbe system, along with a “Certificate of Calibration” for that particular serialized MVB (see Appendix B). The calibration cycle for the MVB is shown on the MVB label along with its serial number (see Appendix B) as well as indicated in the MVP’s C of C as “Next Calibration:” Note that the C of C for the MVB includes information related to the Standards Instruments used to verify the accuracy of the test targets of the MVB. The calibration schedule for the Standards Instruments used to test the MVB is for traceability purposes – *and is not the calibration cycle of the MVB.*
